ULVERSTON CANAL STRAIN GAUGES

# Strain Gauge Measurement Summary Q1 2022

Cadent Gas Limited

**Report No.:** 10325560/01, Rev. 0

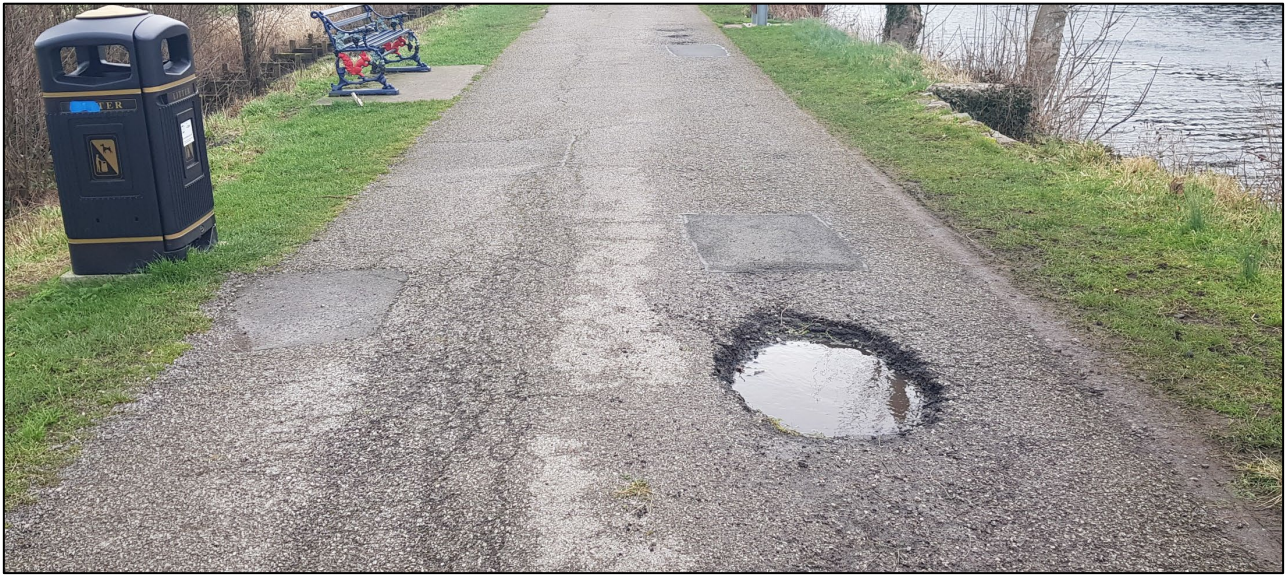
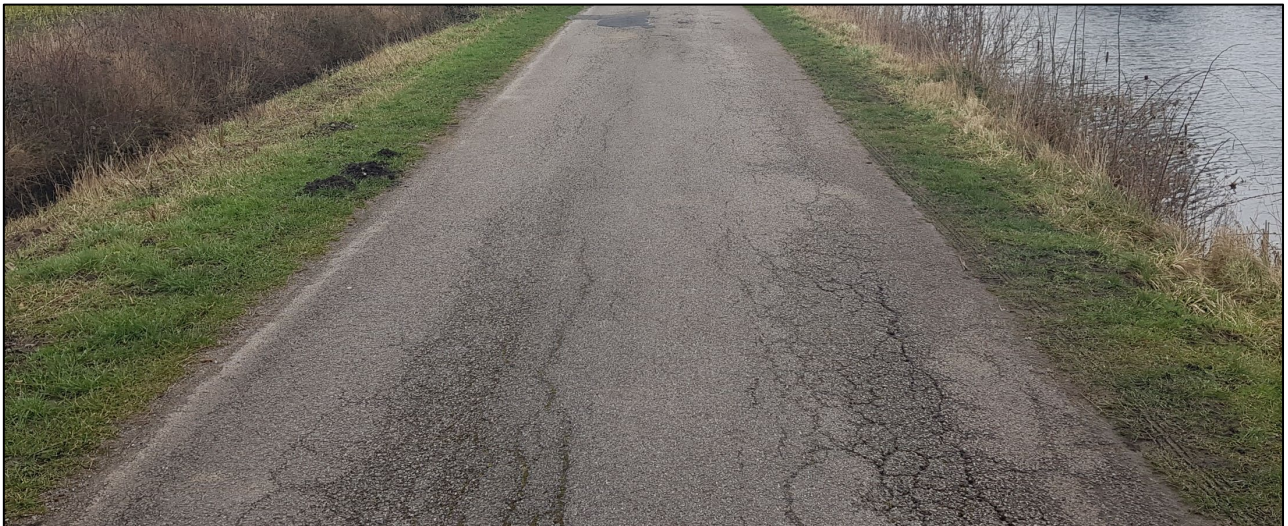
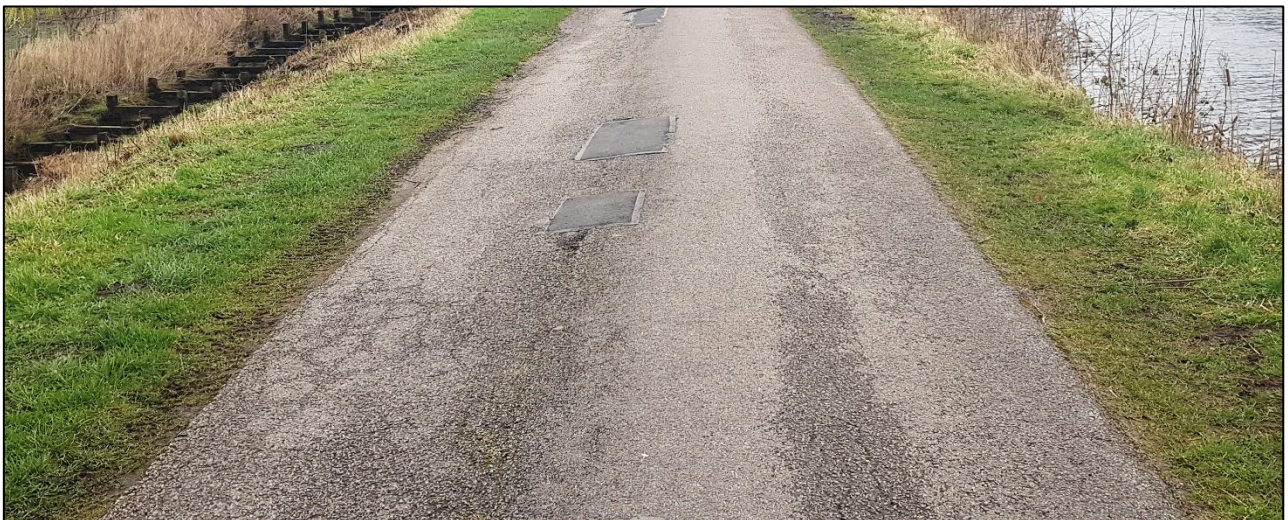
- Rutting from traffic (see Figure 3-1);
- Removal of trees (see Figure 3-2); and
- Repair/remediation of the canal wall.

**Figure 3-1 Examples of ongoing road rutting and damage from traffic**

1. Observations from site suggest that there were no new visible signs of ground movement or settlement of the embankment along the pipeline alignment. However, localised damage to the canal wall and ongoing rutting of the road suggests that the embankment could be susceptible to ongoing maintenance issues in the future.

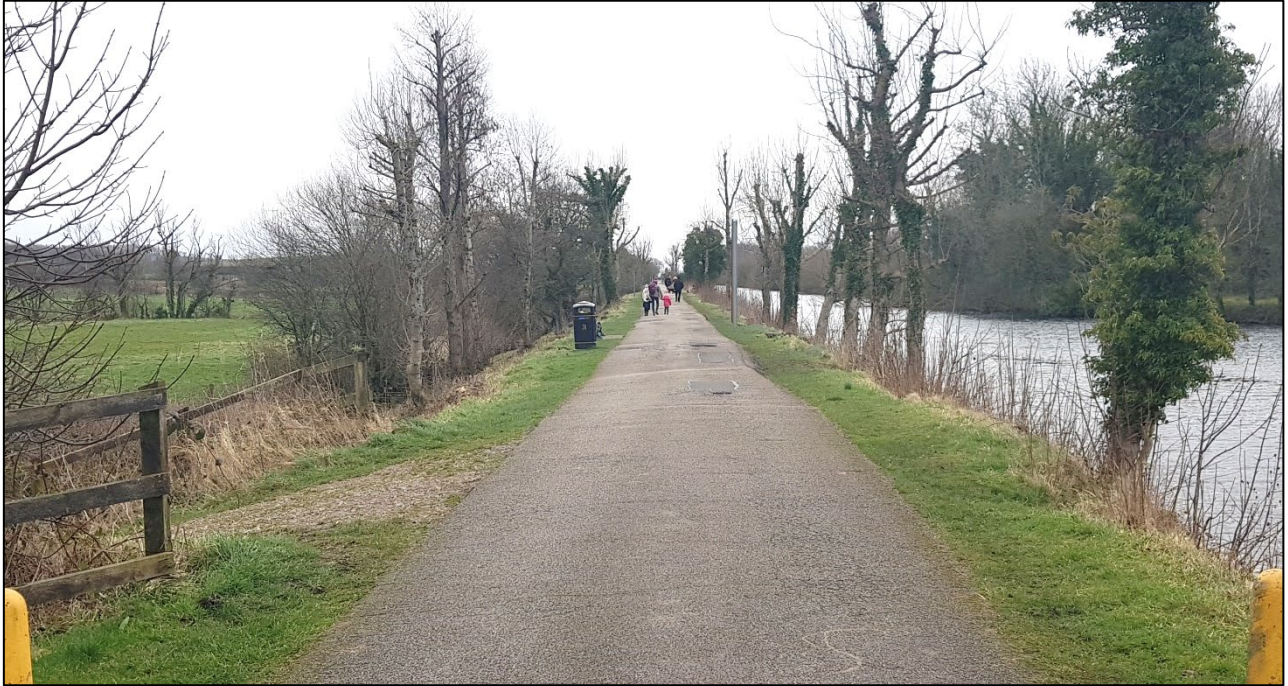
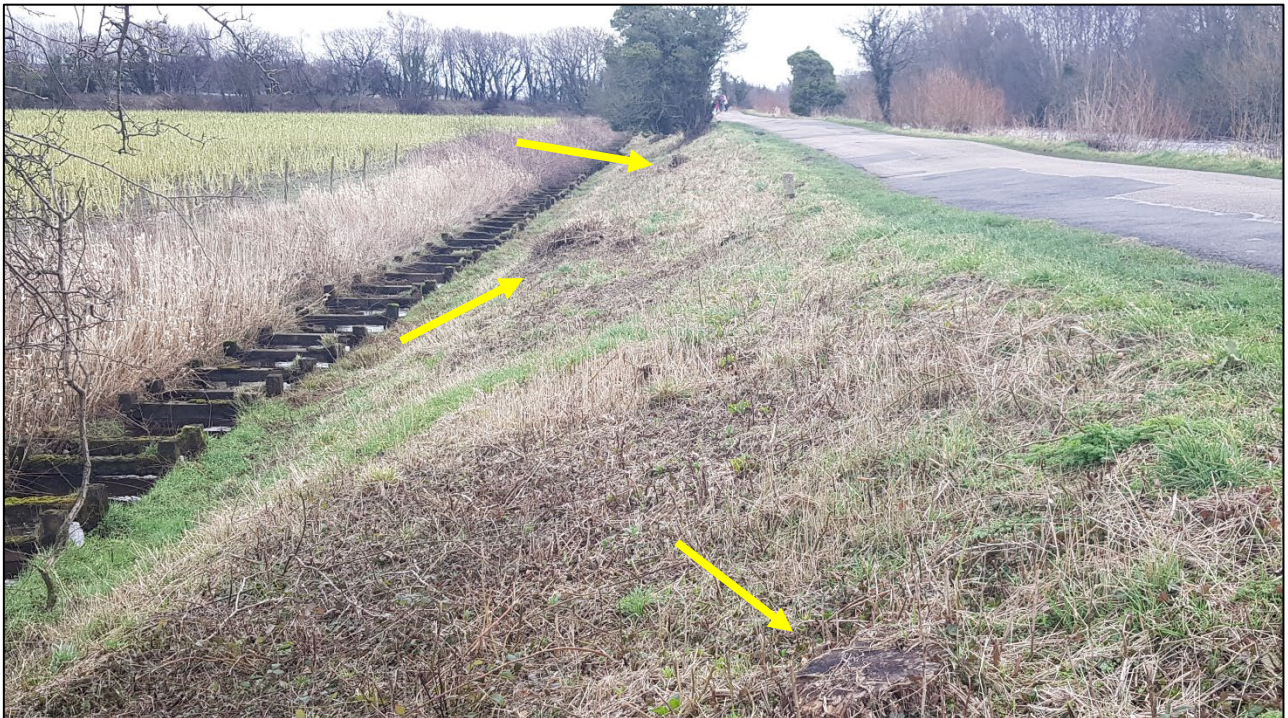
*[Tree removal marked by yellow arrows]*

**Figure 3-2 Examples showing tree removal / heavy pruning**

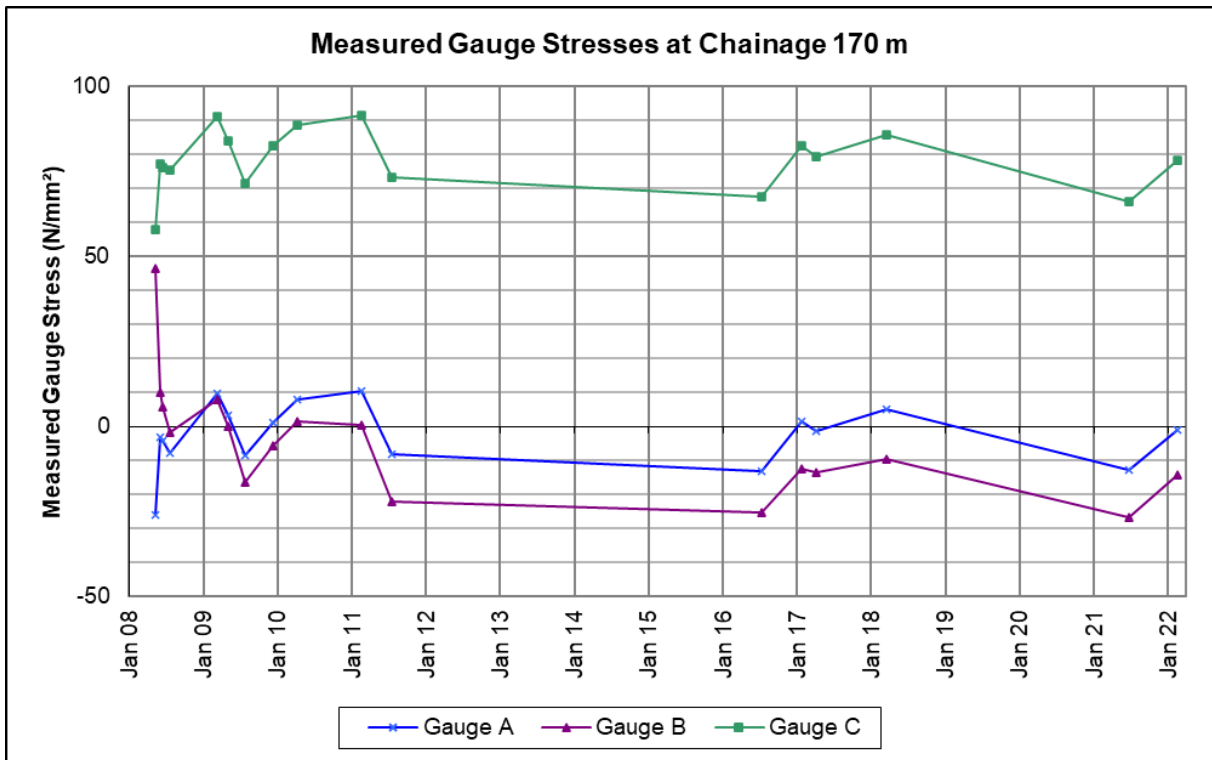
Figure D-1 Chainage 170 m plot of measured strain gauge stress

For chainage 170 m, the results are within expected operational limits, suggesting there is no change in the overall pipeline stress state. The calculated maximum longitudinal tensile stress is  $77.8 \text{ N/mm}^2$ , which is within the upper bound limit, but above the lower bound limit; this has been apparent since the installation of the gauges and commencement of the monitoring. The calculated maximum tensile stress is similar to previous winter months, but below the maximum recorded in February 2011 ( $91.7 \text{ N/mm}^2$ ).

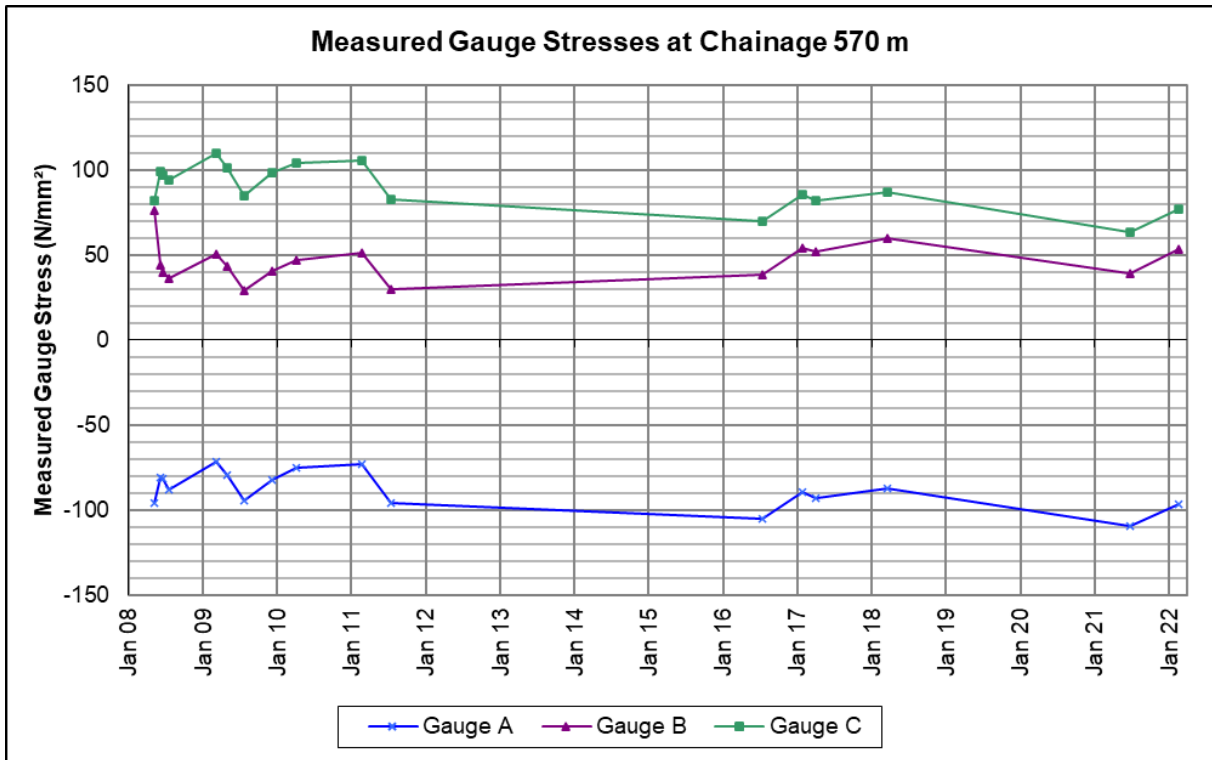
Figure D-3 Chainage 570 m plot of measured strain gauge stress

- Gauge A ( $240^\circ$ ) has seen a small increase in compressive stress (approx.  $15 \text{ N/mm}^2$ ). Gauge A has been in compression since installation of the gauges.
- Gauge B ( $0^\circ$ ) has seen a small gradual increase in tensile stress since 2009 (approx.  $10 \text{ N/mm}^2$ ), although the readings in February 2022 are similar to the previous January reading in 2018. There appears to be small fluctuations between readings in the Q1 period, but these are mostly similar; and
- Gauge C ( $120^\circ$ ) has seen a small gradual decrease in measured tensile stress (approx.  $20 \text{ N/mm}^2$ ) since 2009. Gauge C presents the peak measured tensile stresses compared to gauges A and B.

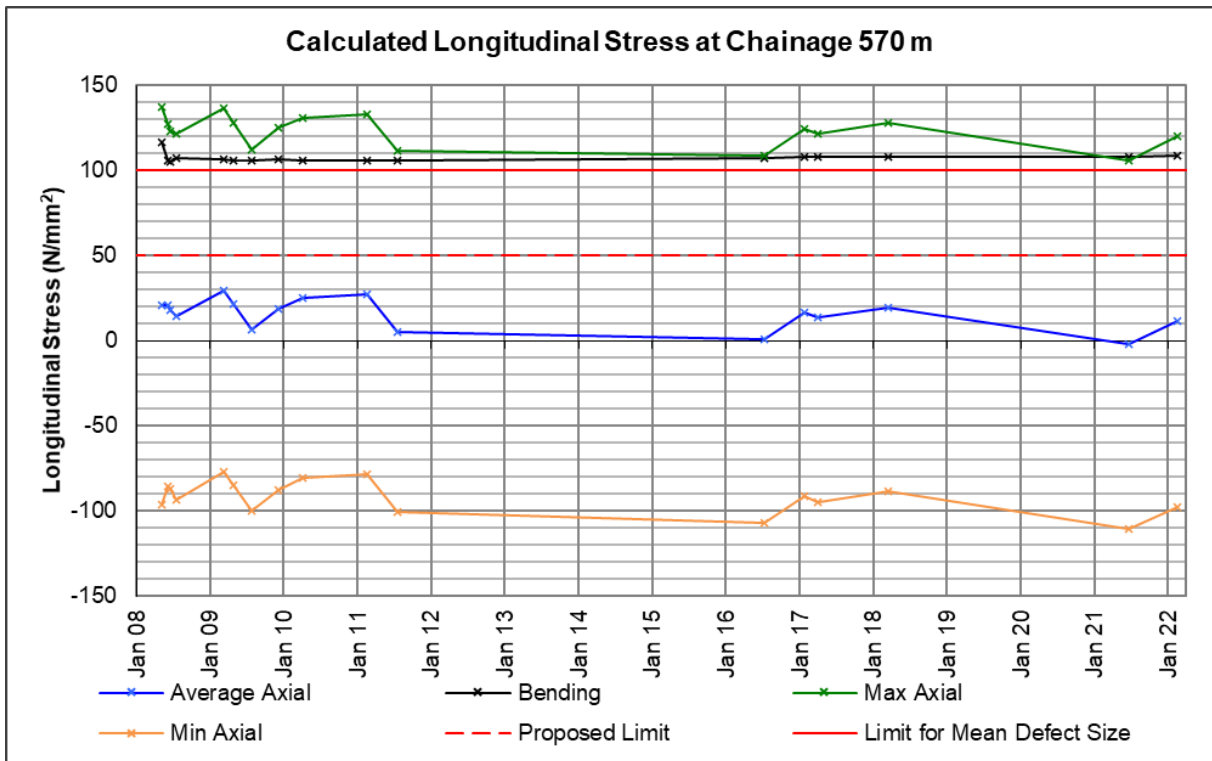
Figure D-4 Chainage 570 m plot of calculated longitudinal stresses

For chainage 570 m, the results are within expected operational limits. The measured and calculated strain gauge values are within the historically recorded maxima. The calculated maximum longitudinal tensile stress is  $120.1 \text{ N/mm}^2$ , which is above the upper bound limit. However, this has been apparent since the installation of the gauges and as mentioned, is below the historical maxima.
